Project Report 152

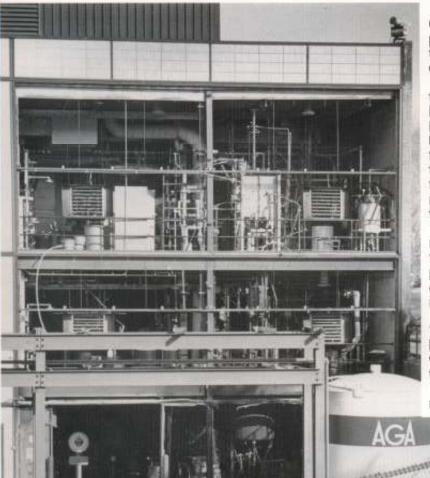
"A fire and explosion at the Ricerca, Inc., Concord Township (near Cleveland), Ohio, plant blew out part of the building, injured four employees and forced evacuation of 50."

Fire Chief John Preuer told reporters that "the wall was designed so the wall would blow out in the event of an explosion. The wall did exactly as it was designed to do."

The Kalwall Blow-out Wall is designed to release from the mounting system when the pressure reaches a predetermined point. Replacing the Panels is easy and economical, and much faster than rebuilding the plant!

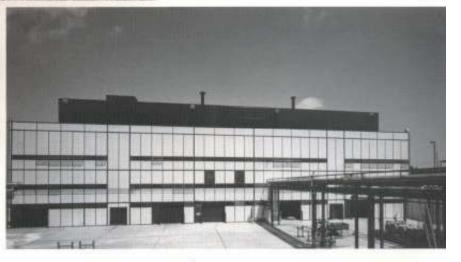
Ricerca, Inc. "before"
